Asbestos / Hazardous Materials Audit & Risk Assessment Report

***Old Bega Hospital
Bega
New South Wales***

October 2018

Job no: 181005

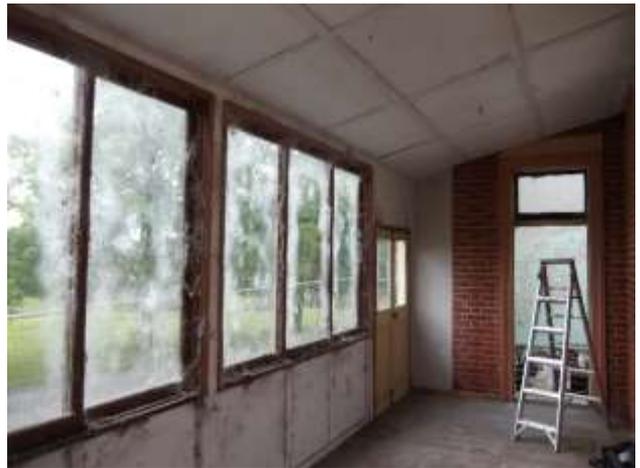
Above: 6) Main building - east sunroom walls / ceiling (non-asbestos)

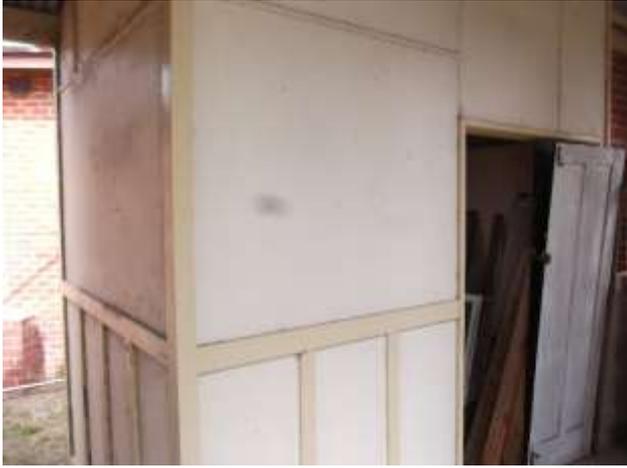
Above: 7) Main building – southeast storeroom walls (non-asbestos)

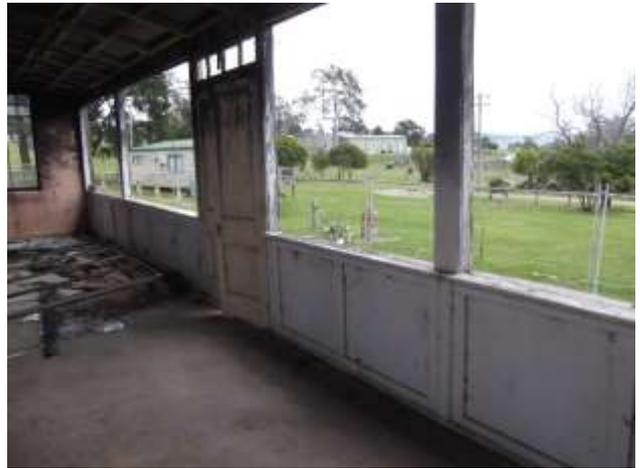
Above: 8) Main building – northwest sunroom lower window panels

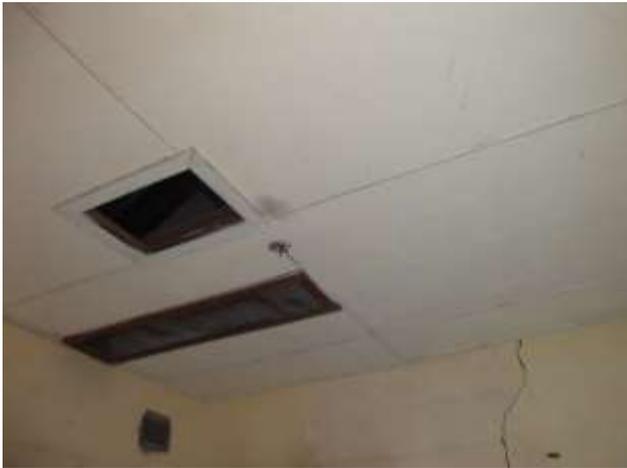
Above: 9) Morgue – east store ceiling lining

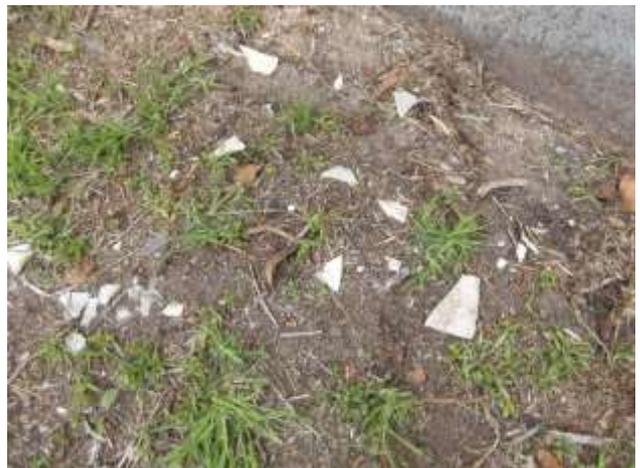
Main building – external to east sunroom	Ground	Asbestos-cement sheet debris	Unsatisfactory Non-friable	Low	-	10	Mixture of asbestos-cement debris & non-asbestos cement debris observed in this location. Remove.
Main building – external – northeast & n/west sunroom	North wall lower window panels	Asbestos-cement sheet	Minor damage Non-friable	Low	As 181005/02	11	Minor damage in some locations. Remove prior to works likely to disturb this material.
Morgue – east storeroom throughout	Ceiling	Asbestos-cement sheet	Stable Non-friable	Low	-	9	No access to west half of this building (locked). Remove prior to works likely to disturb this material.
Operating theatre – west entry room, adjoining kitchenette & east storeroom	Ceiling	Asbestos-cement sheet	Stable Non-friable	Low	-	14	Remainder of ceiling lining in this building is non-asbestos. Remove prior to works likely to disturb this material.
Laundry throughout	Ceiling	Asbestos-cement sheet	Stable Non-friable	Low	-	15	Remove prior to works likely to disturb this material.

Above: 10) Main building – external east wall debris

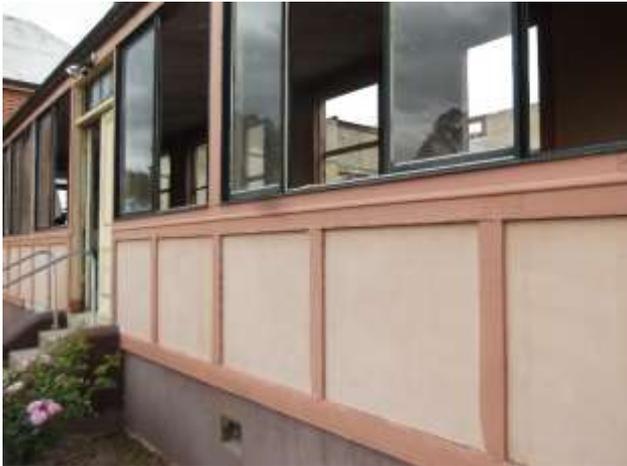
Above: 11) Main building – northwest sunroom – external lower window panels

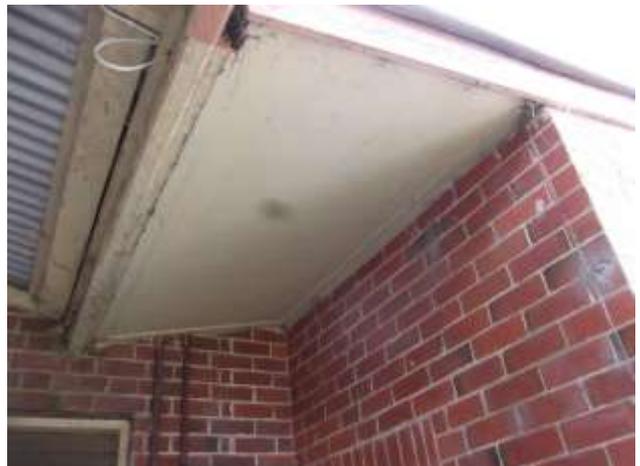
Above: 12) Main building – southeast toilets entry ceiling

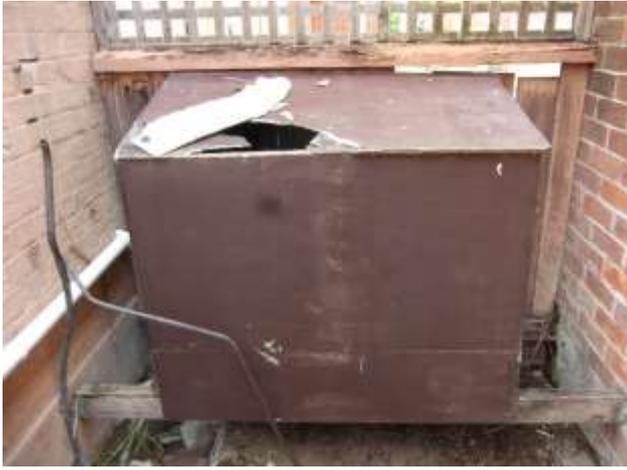
Above: 13) Between main building & morgue – small cupboard lining (non-asbestos)

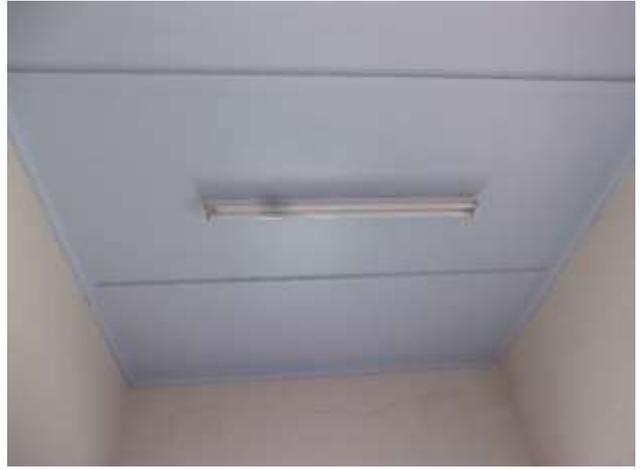
Above: 14) Operating theatre - ceiling

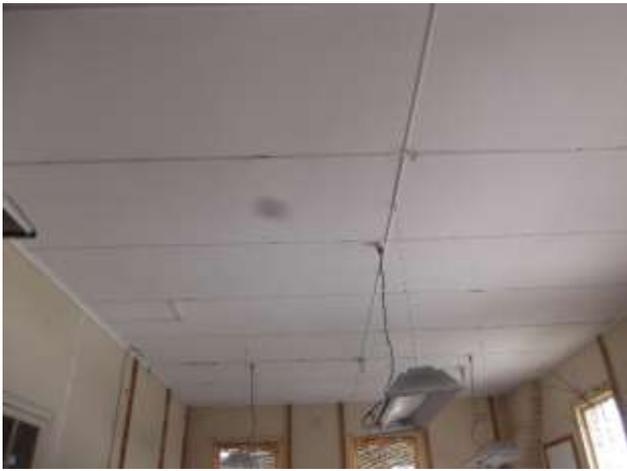
Above: 15) Laundry - ceiling

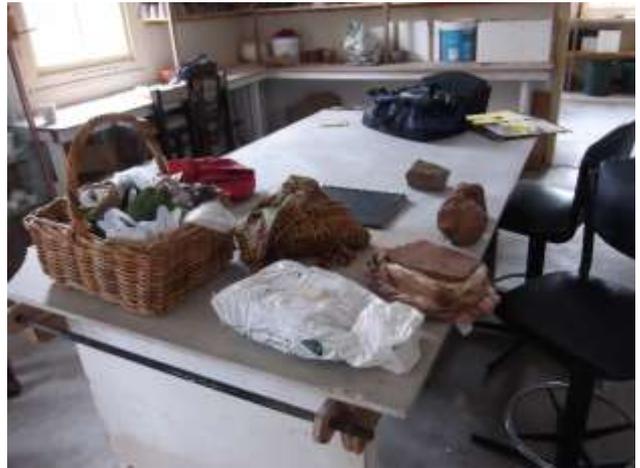
Laundry – central work table	Table top	Non-asbestos	-	-	181005/04	16	<i>Material tested negative to asbestos content.</i>
Laundry – external west electrical cupboard	Electrical board	Non-asbestos	-	-	-	-	
Laundry – external south wall	Wall boards	Non-asbestos	-	-	181005/05	17	<i>Material tested negative to asbestos content.</i>
Former nurses quarters – external east electrical cupboard	Electrical board	Non-asbestos	-	-	-	-

Above: 16) Laundry – central work table top (non-asbestos)

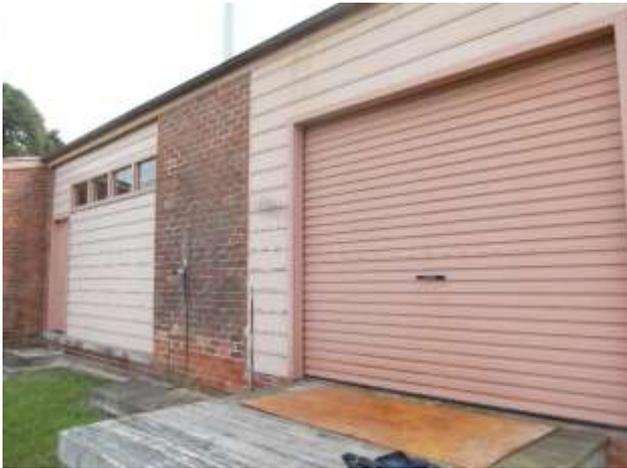
Above: 17) Laundry – external south wall boards (non-asbestos)

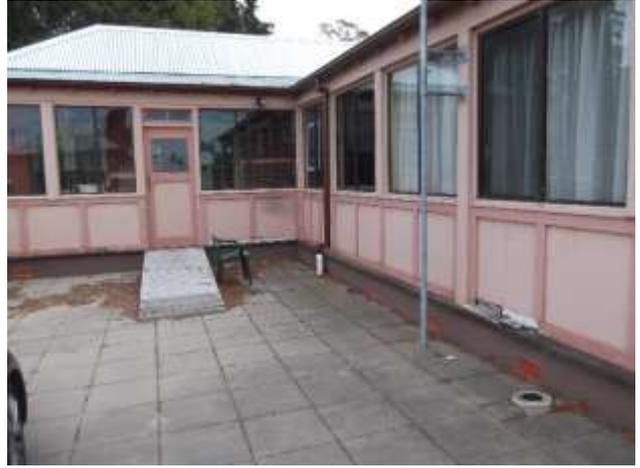
Above: 18) Nurses quarters – external south enclosed verandah – lower window panels

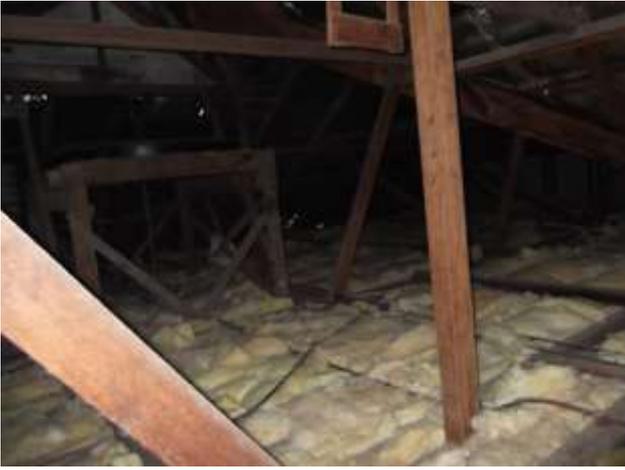
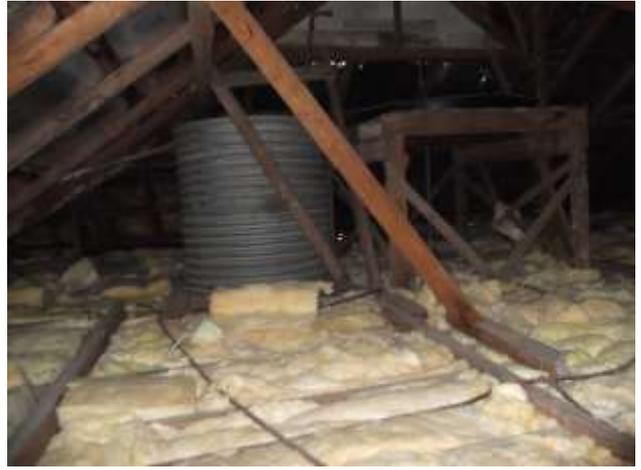
Above: 19) Nurses quarters – roof space insulation

Above: 20) Nurses quarters – roof space insulation

SMF's should be handled, removed and disposed of in accordance with the *Code of Practice for Synthetic Mineral Fibres [NOHSC:2006(1990)]*.

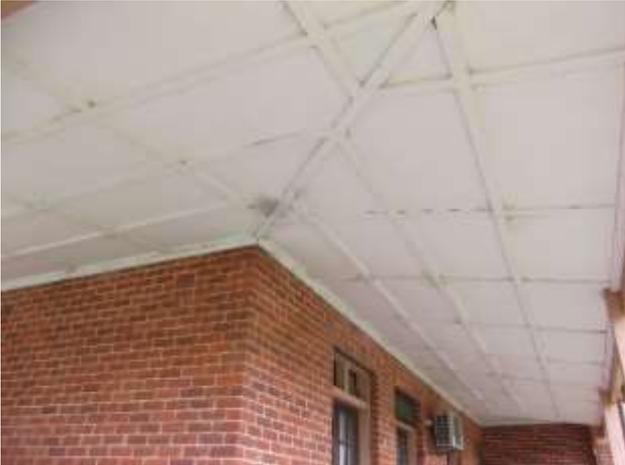
Above: 21) Nurses quarters – verandah ceiling lining

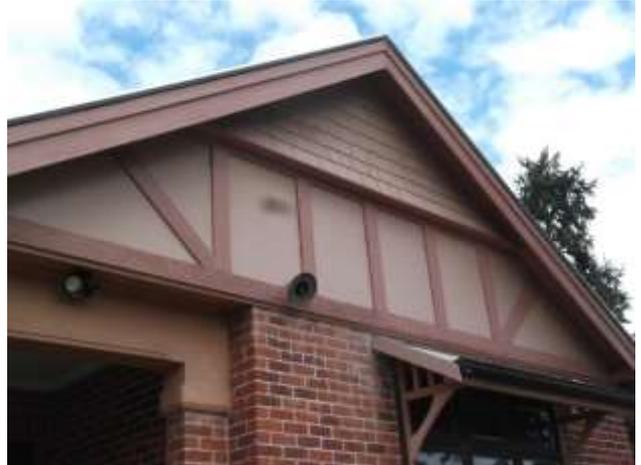
Above: 22) Nurses quarters – north gable panel

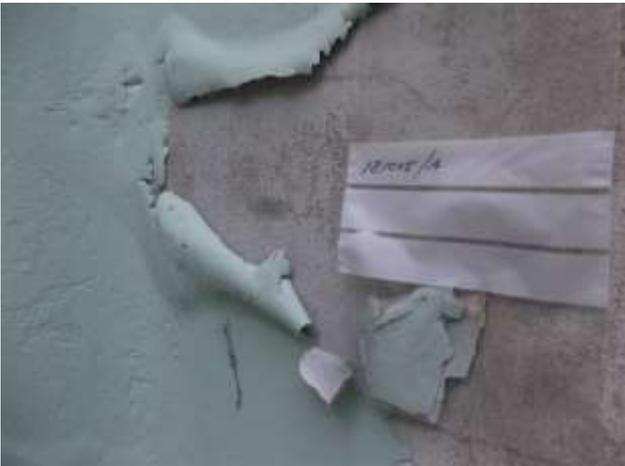
Main building – southeast corner room	Wall paint (pale green)	Lead-based paint	Deteriorating / peeling / flaking	Low	181005/A	23	<i>Remove prior to works likely to disturb in accordance with current WHS & EPA requirements.</i>
Main building – east sunroom – west windowsill	Paint (pink)	Lead-based paint	Stable	Low	181005/B	24	<i>Remove prior to works likely to disturb in accordance with current WHS & EPA requirements.</i>
Main building – east central room	Wall paint (cream)	Lead-based paint	Deteriorating / peeling / flaking	Low	181005/C	25	<i>Remove prior to works likely to disturb in accordance with current WHS & EPA requirements.</i>

Above: 23) Main building – southeast room wall paint

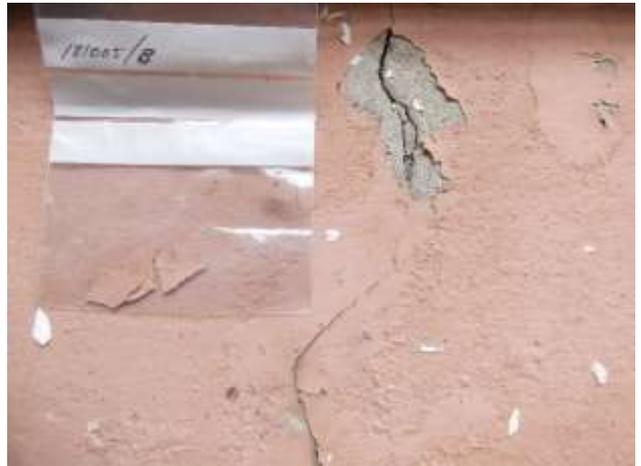
Above: 24) Main building – east sunroom windowsill paint

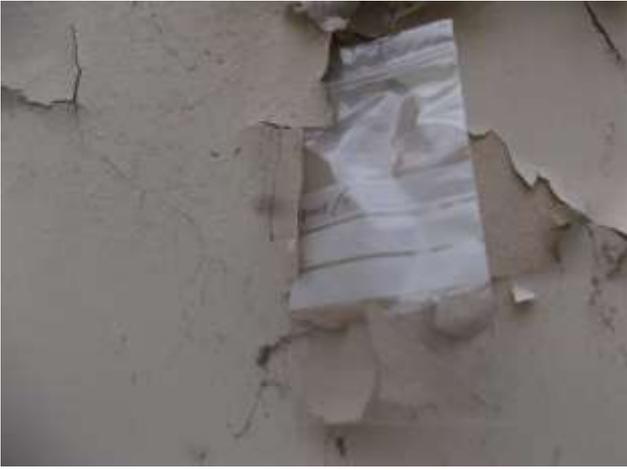
Above: 25) Main building – east central room wall paint
