Old Bega Hospital

Condition Assessment and
Options for Future Management

August 2017

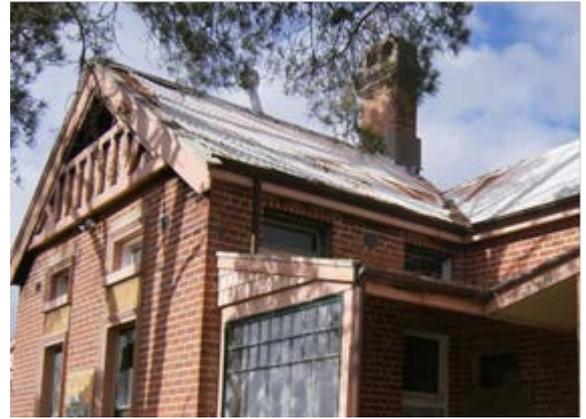
The mostly roofed former 'Day Care' room in the west wing, including adjacent toilet block, is generally dry but in a disused state. It is susceptible to some water ingress at roof/eaves in the NE corner of the room where part of the roof is missing.

The interior of the mostly roofed Private Room (E) and Day Care (W) rooms are protected. However the roof gutters and downpipes are limited. Roof framing and covering however would need to be repaired or reconstructed in order to provide a permanent, safe and compliant covering for long term occupation.

3.1 Section of remaining roof, Day Care area

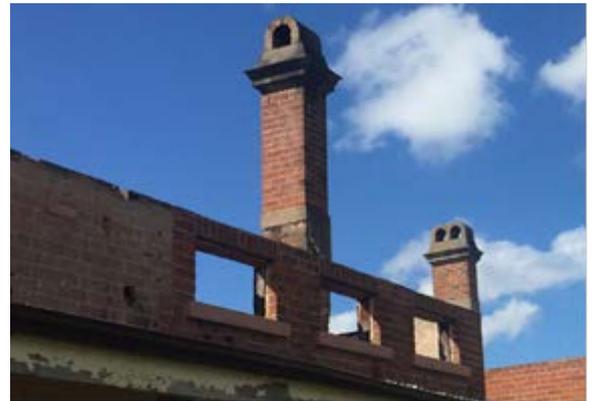
On the main building here are seven brick chimneys, projecting approx. 4m above wall plate level, all with rendered brick cowls (caps). High level inspection was not possible, but the chimneys appear to be structurally sound with no apparent cracking or movement. Fireplaces are mostly intact although with surrounds and finishes damaged or destroyed.

3.2 Chimneys, hospital ward block

Due to the slenderness, it would be advisable to provide strengthening to seismic (earthquake) standards to these chimneys, although this is not a mandatory requirement. This is common practice in NSW public assets and Bega is located in a zone where earthquake hazard mapping has indicated a peak ground acceleration of >0.05g.

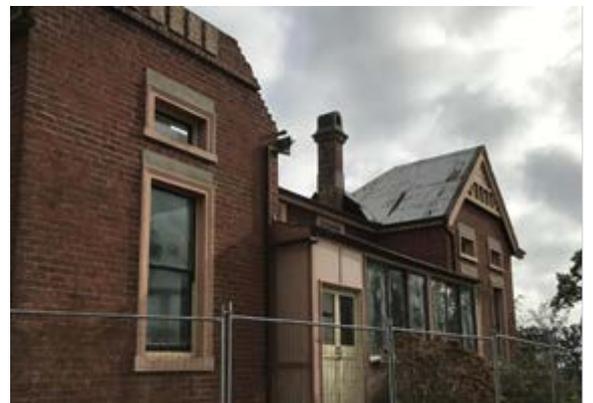
External brickwork and structural walls are generally sound with little sign of movement or cracking. No obvious sign of damage to brickwork due to heat or fire-fighting was seen during the inspection. Brick joints appear largely sound with no serious loss of mortar jointing material affecting stability.

3.3 Brick external walls to private rooms, East end

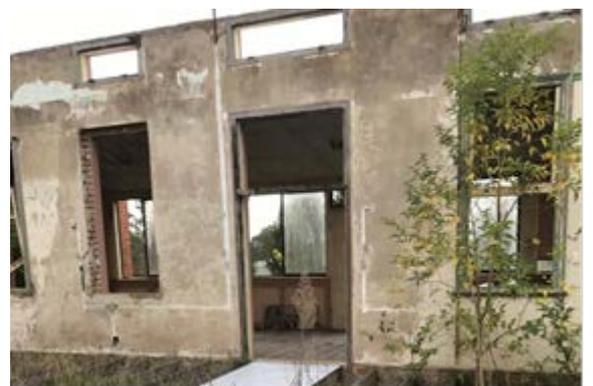
Internal structural walls appear structurally sound but with damage to wall plaster and finishes. Fire damaged timber lintels should be replaced.

3.4 internal plaster and masonry walls with internal windows

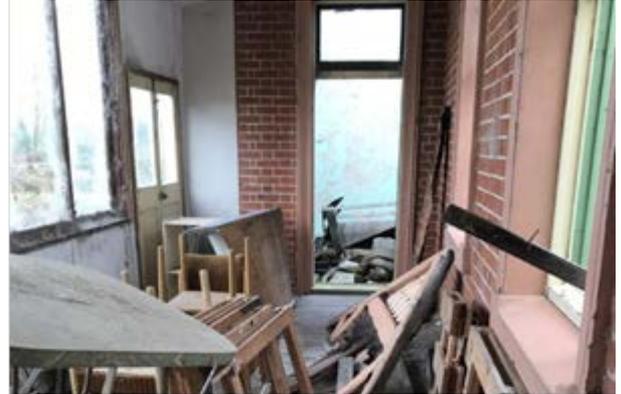
Verandahs to the E side and eastern end of the N side are glazed timber framed (with brick half walls), in fair condition, largely protected from the weather. Part of the southern verandah has a framed storage/ toilet block which is roofed.

3.5 Verandah in use as a store

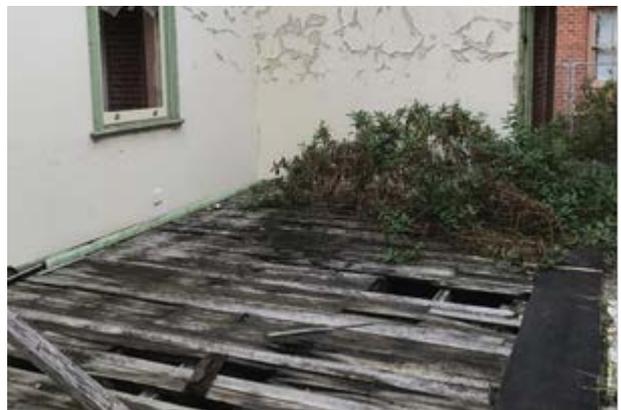
Most floors in these areas have been destroyed by fire or rotted away since the fire. Where protected from weather, joists will require further structural investigation after removal of floor coverings. Minor structural defects were observed to brickwork (minor cracking, loose upper course of brickwork, decay of timber lintels. A section of upper gable above the original north verandah is propped. Otherwise, no serious structural defects (such as foundation failures, leaning/cracking to chimneys/gables or brickwork, collapsed openings etc) were apparent in the walls.

3.7 Decayed floor to Conference Room/Private Room (SE)

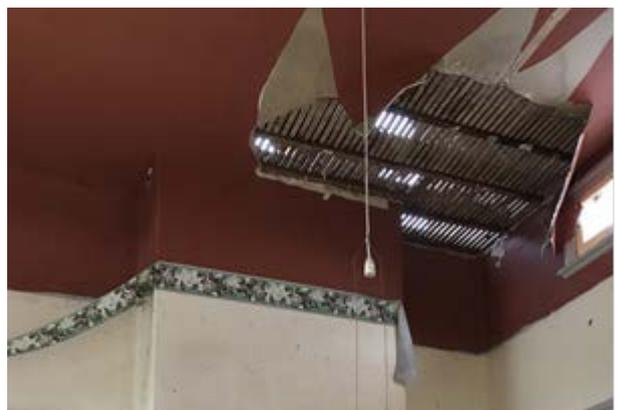
3.8 Ceilings, Private Room (NE)

Fragments of original 1920s lath and plaster ceilings in the roofed parts of the wings survive. Some have been clad with gyproc panels. Fibro ceiling panels in roofed verandahs appear to be in sound condition. These could be left undisturbed and maintained to limit WHS issues.

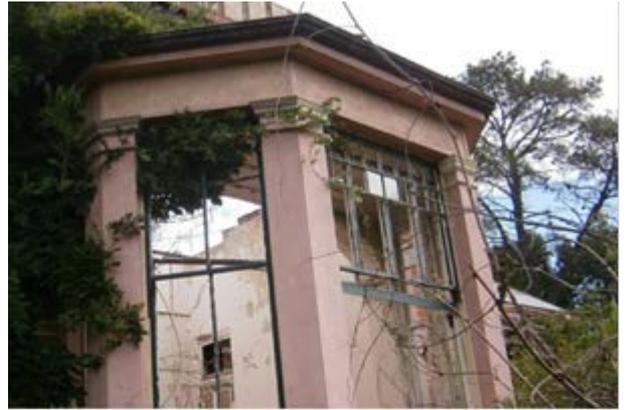
Except for the roofed areas above (which have windows and most or all glazing intact) most of the glass in the windows has been broken or removed. Remedial work is necessary to either temporarily or permanently exclude driving rain, birds, vermin, intruders, etc. from window and door openings not in current use.

3.9 Sash windows, N façade bay window

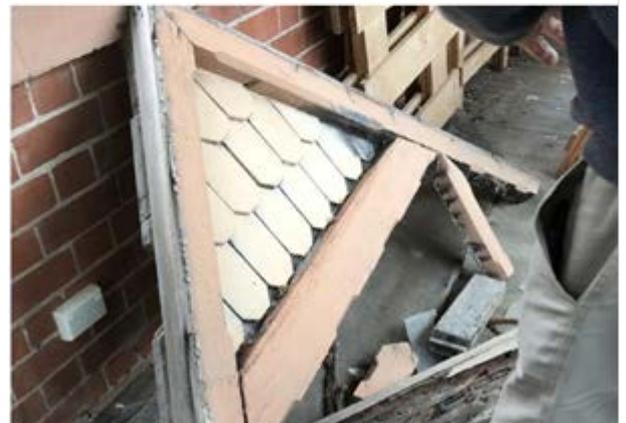
Approximately 50% of original exterior timber door and window frames survive in situ. Almost all timber joinery in the Mens Ward has been removed or destroyed. In several areas components have been salvaged and stored for potential repair. Much of the surviving timber work is repairable. A good quantity of barge boards, fascias, gable half-timbering/shingles and verandah flooring also survives, which would enable reconstruction/ reproduction of damaged or lost features.

3.10 Salvaged gable frame from E elevation

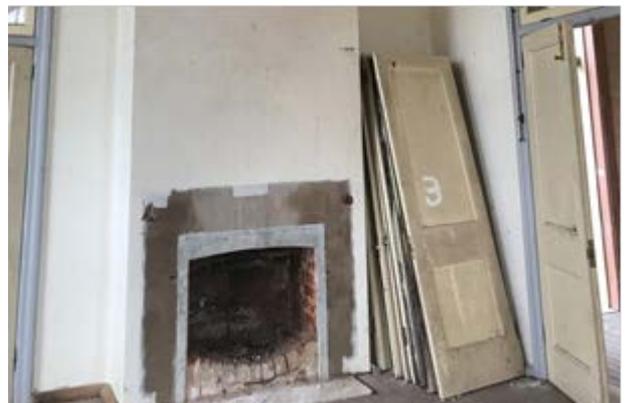
3.11 Internal joinery stored in Private Room (NE)

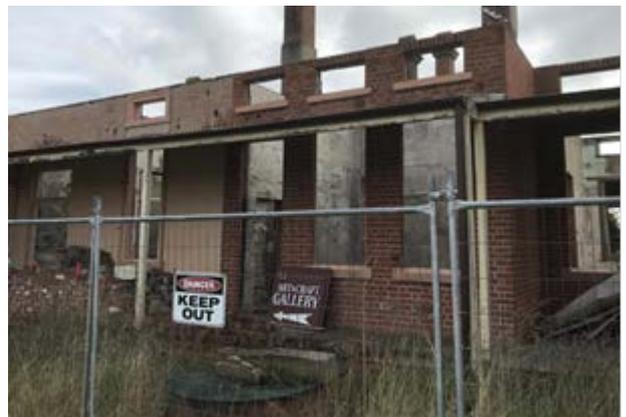
A few missing or insecure openings have been boarded for safety. For the site as a whole, security signage and fencing (combined with partial occupancy) is the only form of security.

3.12 Security fence, signage, S Verandah

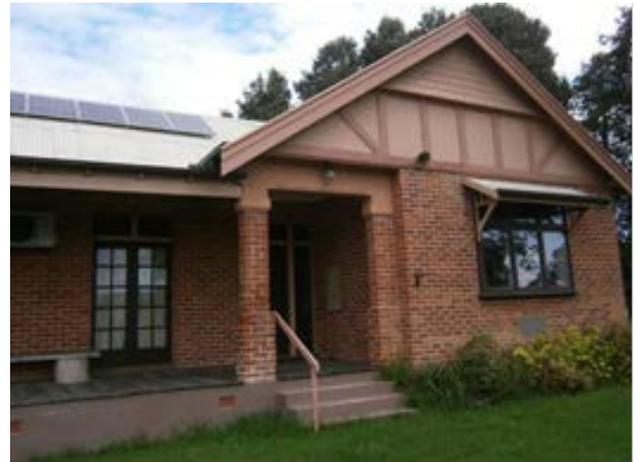
The building has signs of roof failure including leaking roof sheets on the east side and heavily corroded valleys and sheets on the southern wing.

Interiors are in good or fair condition but with some signs of water leakage from defective roofs.

3.13 Nurses' Quarters

Added as a separate Option. The Nurses' Quarters building is in use and has potential for further use and/or minor alteration but requires urgent roofing repairs and minor internal works/maintenance.

Replace roof sheeting with new galvanised roof sheeting to match existing style plus allowance for minor ceiling repairs, internal painting and termite inspections.

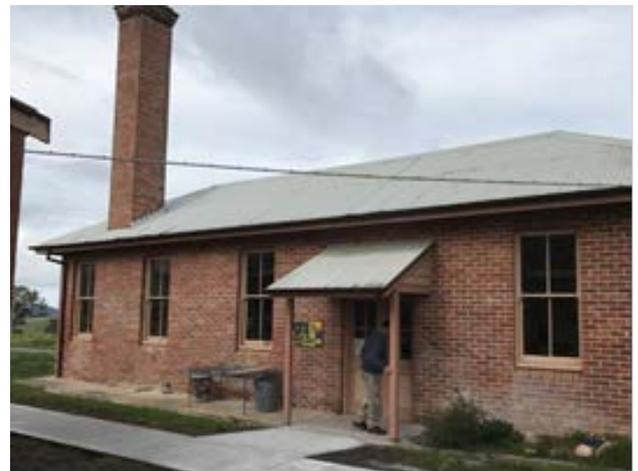
The laundry is a brick-built single-story building with two chimneys (one tall, one short) and a rear lean-to. Brickwork is in good condition apart from small areas of missing pointing. Walls/chimneys show no sign of structural defects. The building has a painted corrugated metal roof in good overall condition, and functioning rainwater/stormwater services. External joinery and glazing, and external paving are in good condition. The interior was not inspected.

3.14 Laundry

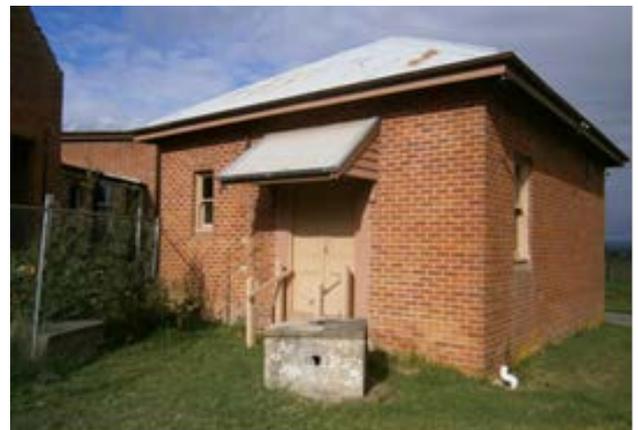
The Operating Theatre is brick with galvanised corrugated roof. External roofing appears sound except for minor rust patches. Rainwater services are good or fair. External joinery, glazing and brickwork are in good or fair condition. The interior was not inspected.

3.15 Operating Theatre

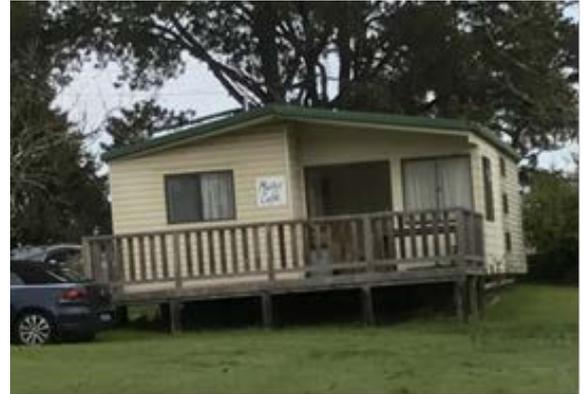
The cottage is a modern timber framed prefabricated building on brick piers with a sheet metal roof. It is in good overall condition.

3.16 Cottage
